Support Surface Materials and Design Innovation:

Preventing Fluid Ingress and Maximizing Investment Returns for Hospitals

Presented at
NOVA 2024

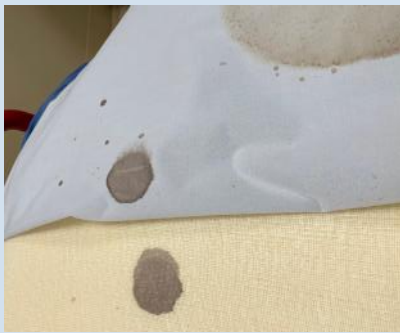
Typical design allows any fluid ingress to immediately damage internal components — likely requiring full asset replacement.

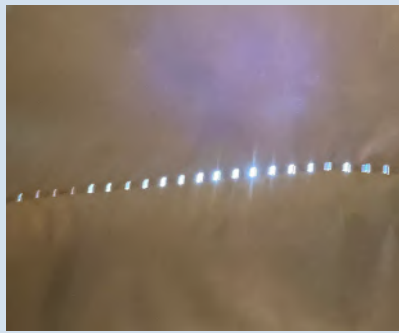
Traditional sewing methods punch thousands of holes into the fabric, creating openings for fluid ingress along every seam.

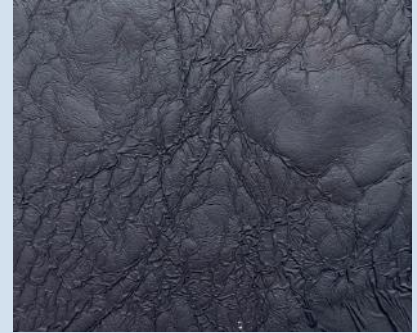
Most top cover fabrics lose their waterproofing when exposed to disinfecting chemicals — allowing for fluid ingress (*photos: 5 days in bleach*).
