Support Surface Materials and Design Innovation:

Preventing Fluid Ingress and Maximizing Investment Returns for Hospitals

Presented at
NOVA 2024

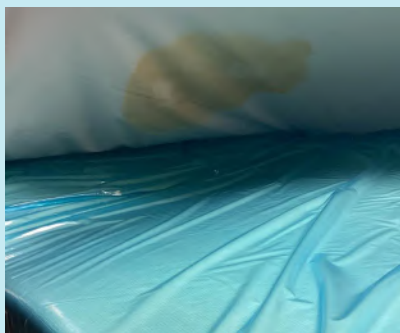
CoreShield™ liner protects the internal components from potential fluid ingress and damage — likely requiring only top cover replacement.

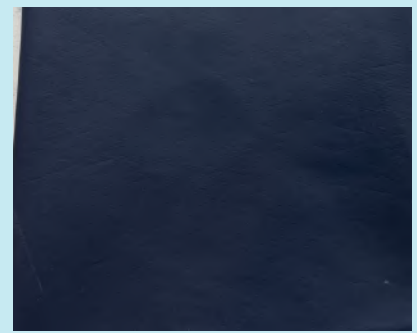
Highly chemically resistant fabrics withstand harsh cleaning protocols and help maintain a waterproof covering (*photos: 10 days in bleach*).
